Keeler St. Porous Pavement Pre and Post Maintenance Infiltration Test Results

То:	Valerie Novaes, PE, DWSD
Cc:	James Rydquist and Dan Christian
From:	Tiffany T. Neubig
Date:	December 14, 2017
Subject:	Keeler St. and Artesian St. Porous Pavement Infiltration Testing

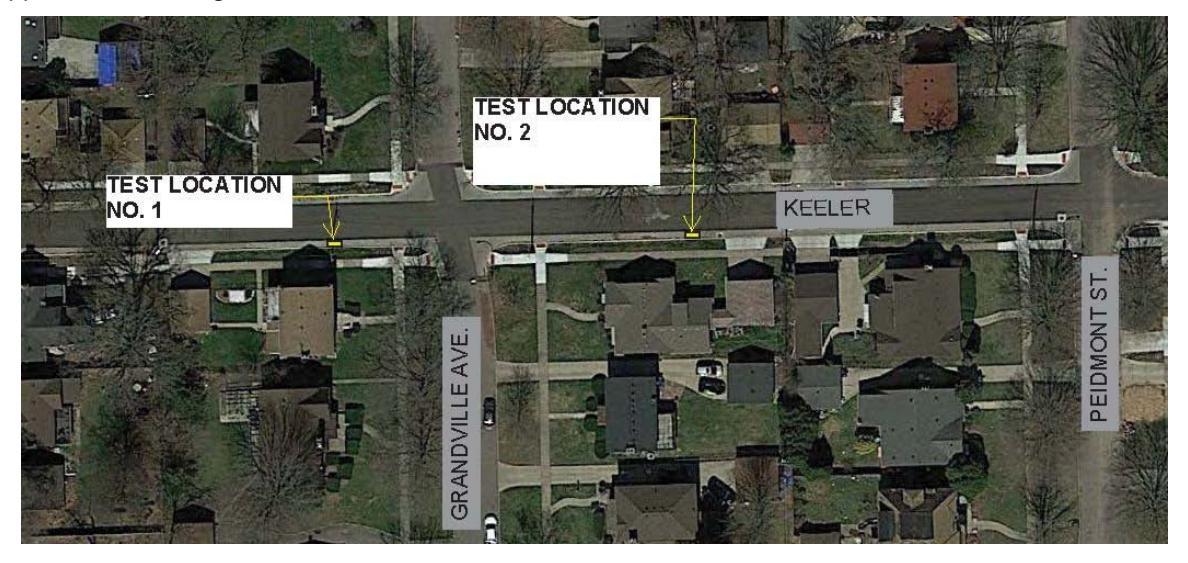
Figure 1 Keeler Test Locations

Keeler Street contain PaveDrain system installed in the parking lanes along two city blocks between Outer Drive and Piedmont St. Infiltration testing was performed on each block on the south side of the road; Figure 1 shows the approximate testing locations.

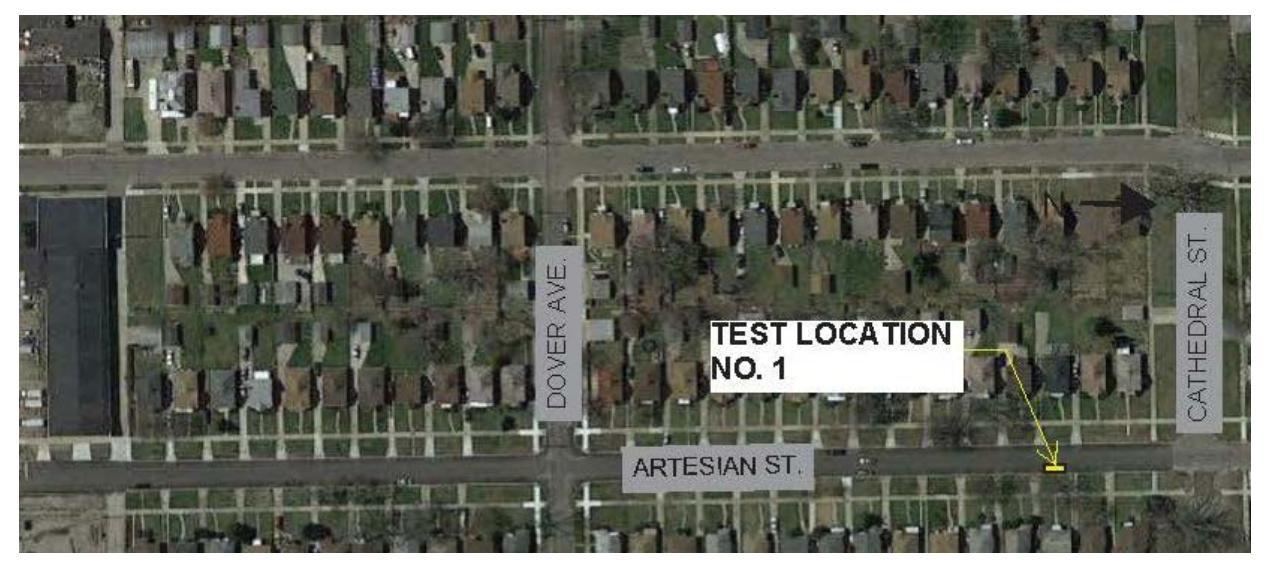
Figure 2 Artesian Street Test Location

Artesian St. contains porous asphalt along two city blocks between Joy Road and Cathedral Street. Infiltration testing was performed on the east side of the road just south of Cathedral as shown in Figure 2.

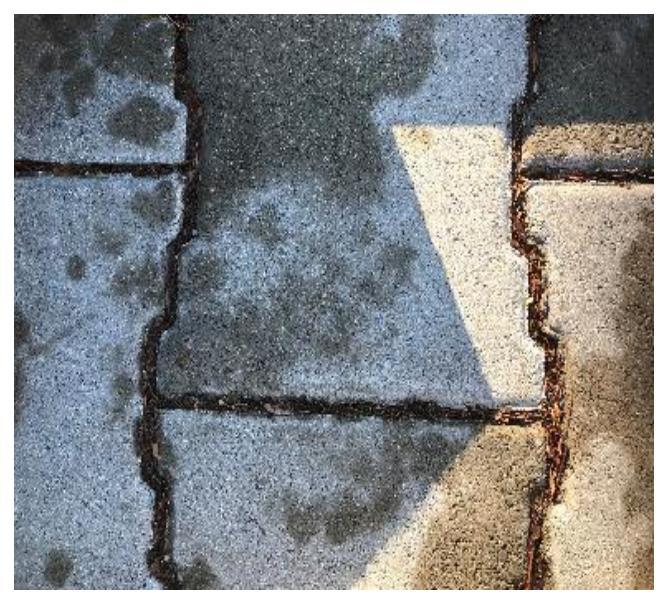
Infiltration rates increased substantially after cleaning of the pavement based on all test results. Table 2 provides a summary of each test at each site location. The infiltration testing prior to cleaning resulted in low infiltration rates. Upon visual inspection it was noted that Keeler St. had debris filled up to the top of the PaveDrain block and Artesian St. was visibly clogged on the surface.

Location 1 PaveDrain Prior to Cleaning

On December 1, 2017, infiltration testing was performed at two separate locations on Keeler Street PaveDrain system and one location on the Artesian Street porous asphalt to determine how the two systems are operating without regular cleaning maintenance. On December 4, 2017, DWSD cleaned the area of PaveDrain and porous asphalt using the recommended PaveDrain attachment that is attached to a vacuum truck. On December 5, 2017, infiltration testing was performed at the same locations to determine the infiltration rate after cleaning. The results of the before and after testing of the infiltration of the pervious pavement is included in the attached memo.

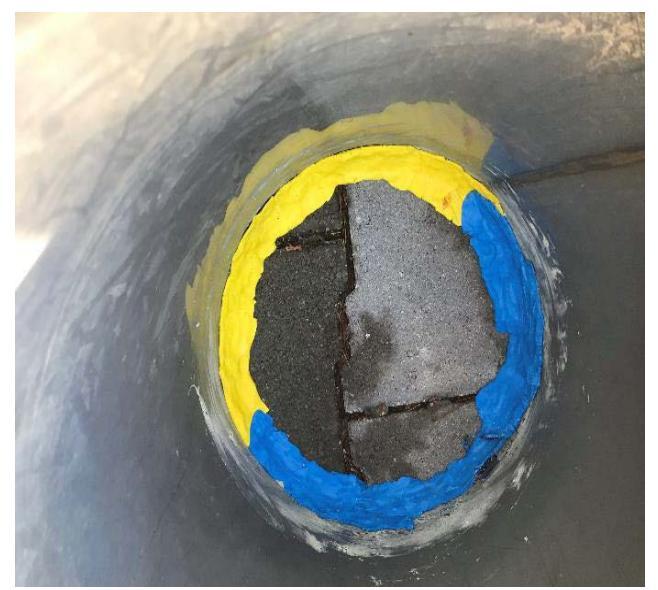
ASTM test ring on the PaveDrain

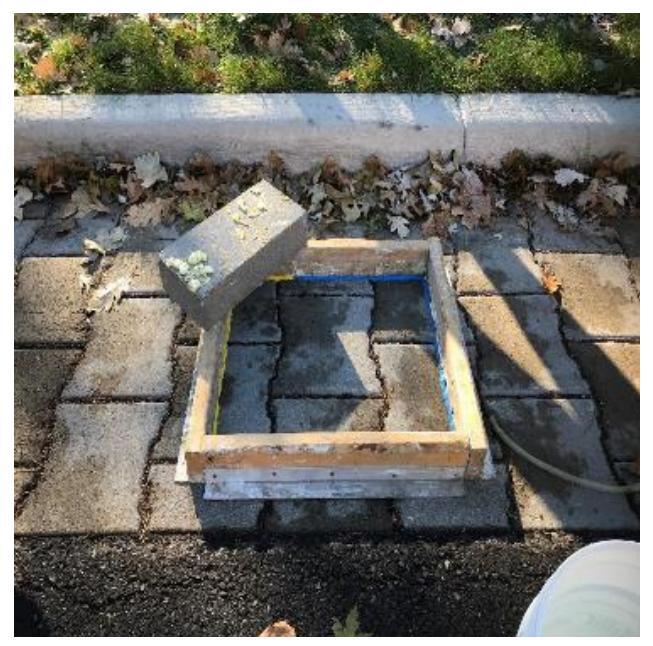
NCSU SIT Test Square
