Water Quality Concern for Kalamazoo River Tributary Streambed Restoration

The Water Treatment System

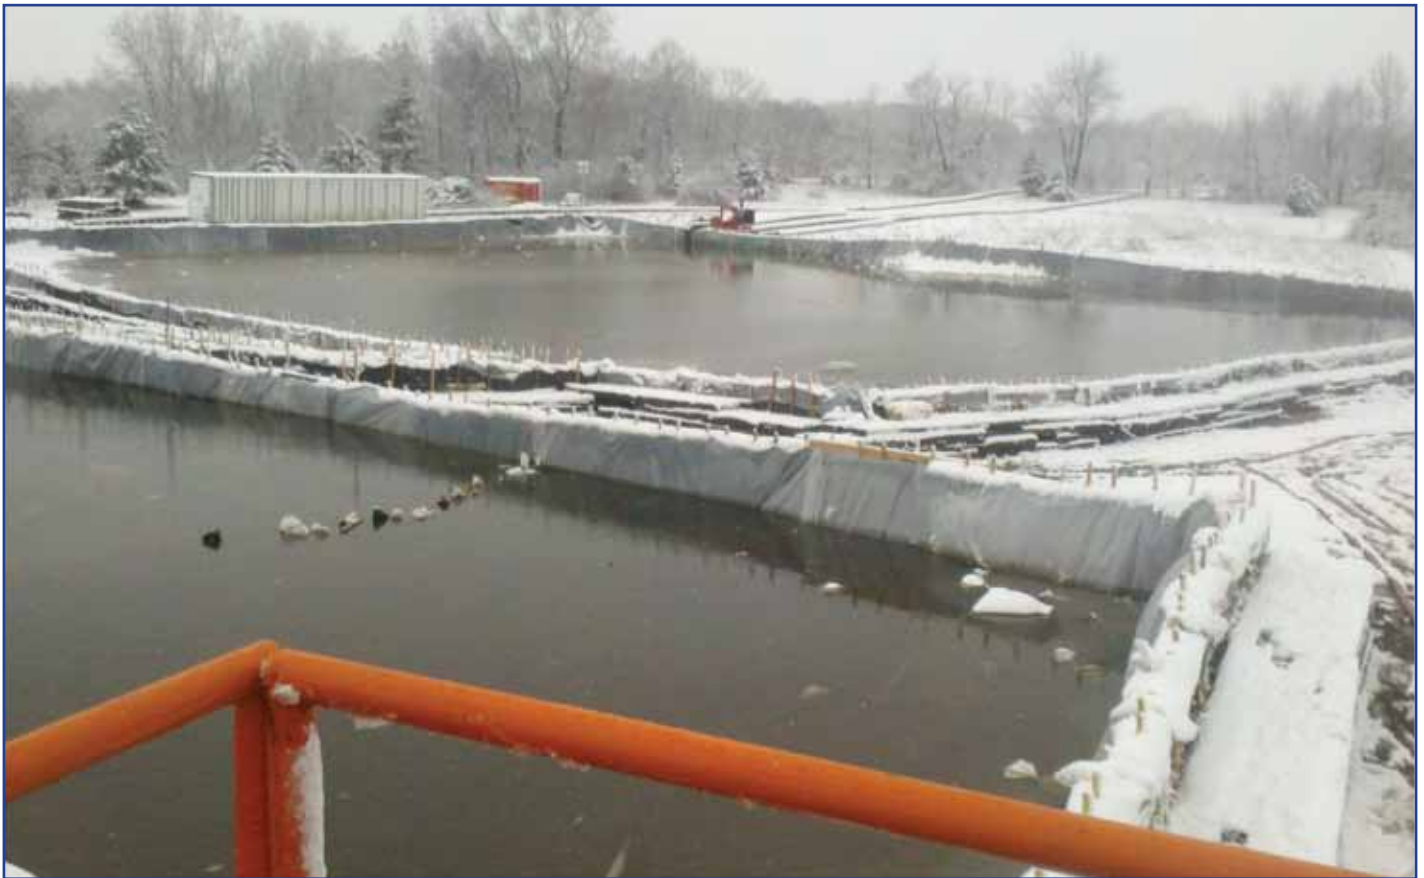
View of ponds from the top of container based water treatment and clarification system.

The WaterMatrix is a large container based water treatment and clarification system that includes three distinct modules in the tankage, a mix area, a settling area and a capture area. The mix area is used to provide the turbulence and contact time with the polymers necessary to start the initial flocculation of the suspended solids. Water

Interface H2O provided a conceptual design plan for two settlement ponds, each 0.8 acres and operating depths of 3 feet (aprox. 750,000 gallons each). Each settlement pond was designed to slow water flow rate to maximize flocculent settling and capture. In the narrow conveyance connecting the two ponds, jute net capture devices were installed to enhance flocculent capture during flood stage pumping.
